Tropical Mold Forest

Proper Plant Placement can Prevent Problems

by Peter Sierck

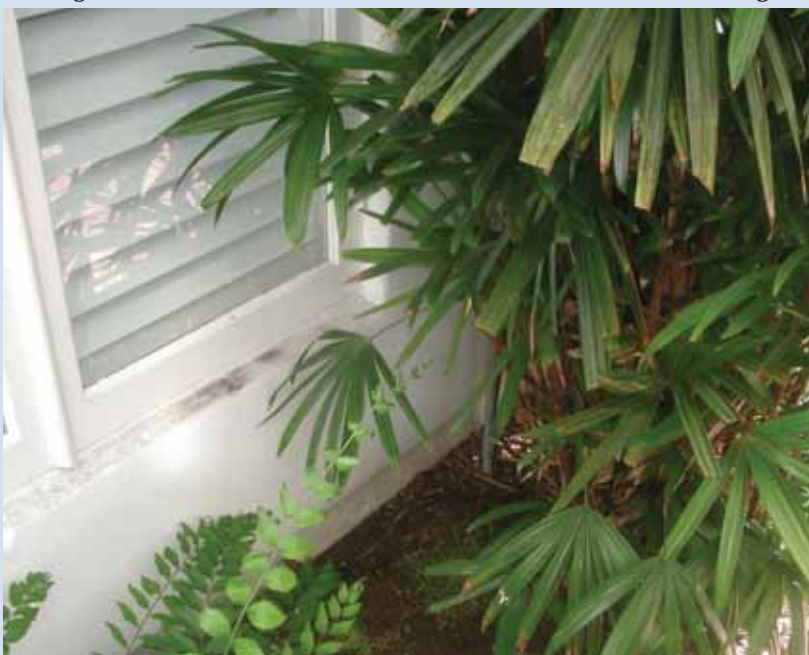
Sprinkler overspray patterns were visible on the stucco, causing some of it to flake off. Wood rot was noted at the base of the French door casings. Brick stone veneer was present in some areas. Rain gutters were missing and the site drainage system was questionable.

Lush vegetation hid the beginnings of wood rot on this French door.

It is of the utmost importance that all the water intrusion sources are identified and eliminated to prevent a recurrence of moisture damage and subsequent mold growth. Tropical plants require tremendous amounts of water and should not be planted close to a structure. Local drought-resistant plants require far less water and can be a beautiful substitute in xeroscape landscaping. Sprinkler system overspray should never hit the exterior building envelope because eventually moisture will migrate through the building paper and it will cause material deterioration. Drip-irrigation systems are a good substitute and will dramatically reduce the amount of water delivered to the plants and the structure. Rain gutters diverting the water away from the structure and a properly functioning site drainage system should be installed.
