# Tropical Mold Forest

## Proper Plant Placement can Prevent Problems

by Peter Sierck

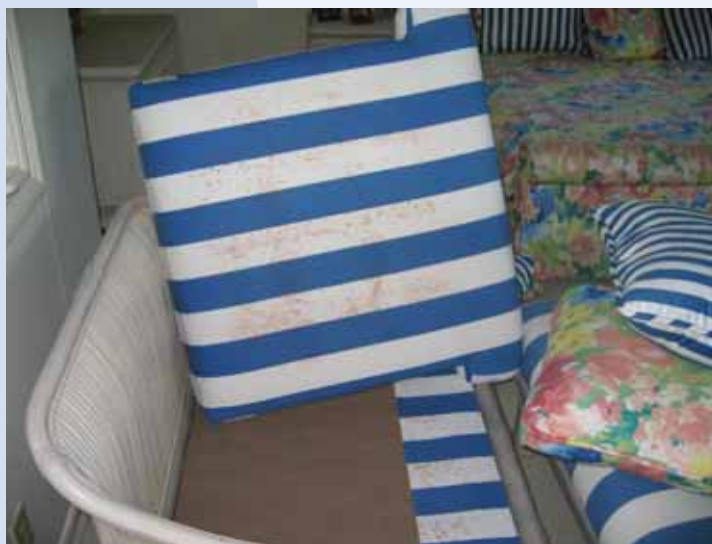
Guesthouses are especially problematic and notorious for mold problems. They are infrequently occupied and therefore not heated in the winter nor ventilated in the summer. This can easily cause a high moisture load indoors causing xerophillic fungi to grow on surface materials. Many of the soft fabrics furnishings in this guesthouse had to be discarded due to the confirmed presence of active surface mold growth. A thorough deep-cleaning of all remaining surfaces was performed and the carpet and padding was replaced. A dehumidifier was installed in the ventilation system and the system is now controlled by a humidistat and thermostat. This will insure that a certain relative humidity level is not exceeded and adequate temperatures are maintained.

This guesthouse was not so inviting when mold was the visitor.

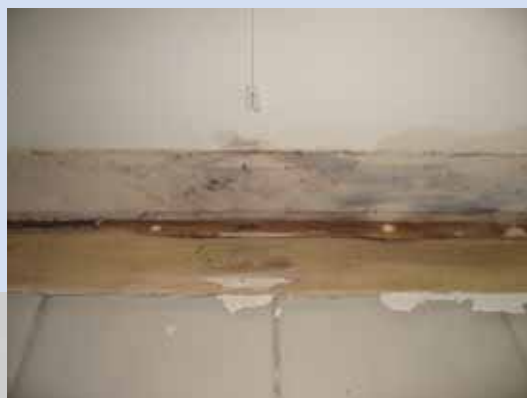
Baseboards were removed in selected areas and small exploratory cut-outs were made into the drywall. Mold growth was present on the back side of the baseboards and on the bottom section of the walls. The back sides of the drywall cut-outs also show significant mold growth.

The mold growth, indicated by a strange odor and subsequent air samples, was fully revealed once the baseboard was removed.

made to remediate the guesthouse with a full containment. The drywall and insulation material was removed and replaced up to four feet high. During the removal process, deterioration of the building paper was detected in some areas. This required the removal of the exterior stucco to re-install a continuous drain plane membrane. After being cleaned via HEPA vacuuming and damp wiping, the containment work areas were tested and cleared for mold levels. Reconstruction of the interior could start, but the original water intrusion problem had not been yet been addressed.
