# Flowing Downstream: The Case of the Hidden Flood

by Peter Sierck

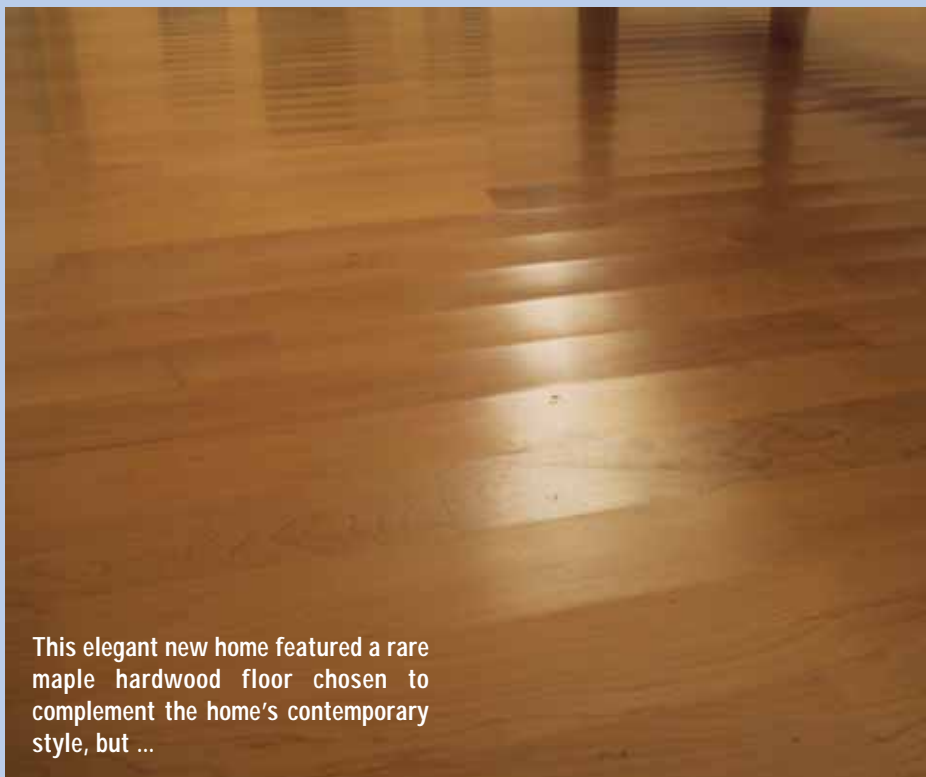
This elegant new home featured a rare maple hardwood floor chosen to complement the home's contemporary style, but ...

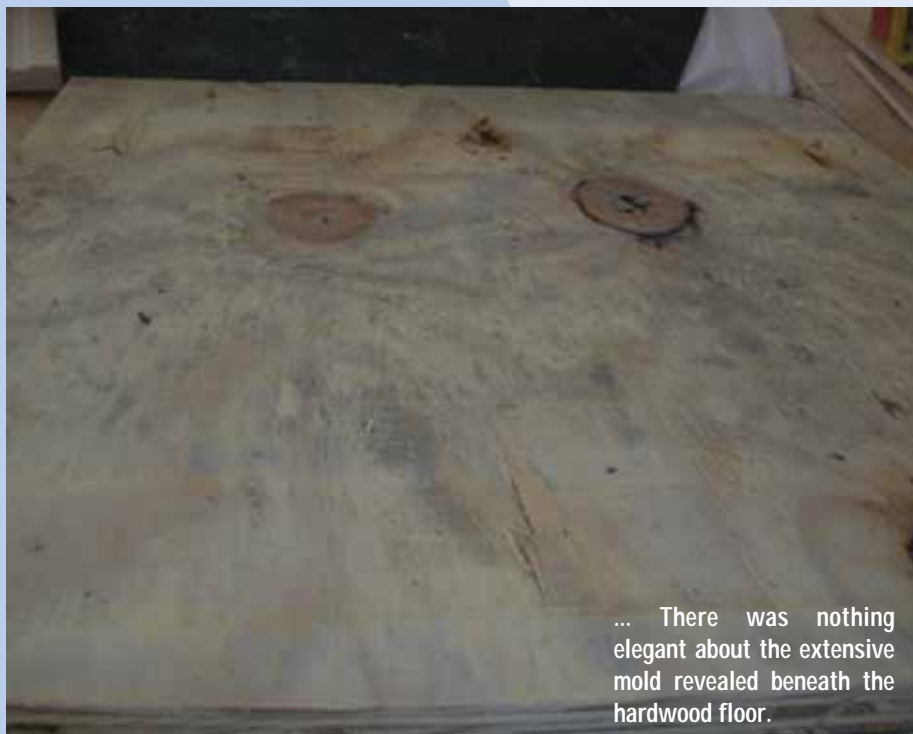
Once opened up, visible fungal growth was present on the

plywood sheeting and the sleepers. The readings of the moisture measurements in the sleepers and in the plywood were elevated and a laboratory analysis of the surface samples collected confirmed the presence of *penicillium* and *aspergillus*. Removal of the drywall sandwiched behind the cabinet also revealed active mold growth on the drywall materials.

... There was nothing elegant about the extensive mold revealed beneath the hardwood floor.

It was suspected that the water had traveled throughout the first floor. More exploratory cut-outs confirmed that theory. The flood had affected the entire hardwood floor on the first floor and removal and reinstallation was recommended. The kitchen cabinets were removed to replace the swollen particle-board and the moldy drywall.
