No Time to Waste

A Mold Remediation. A Timeline of Aggravation

by Peter Sierck

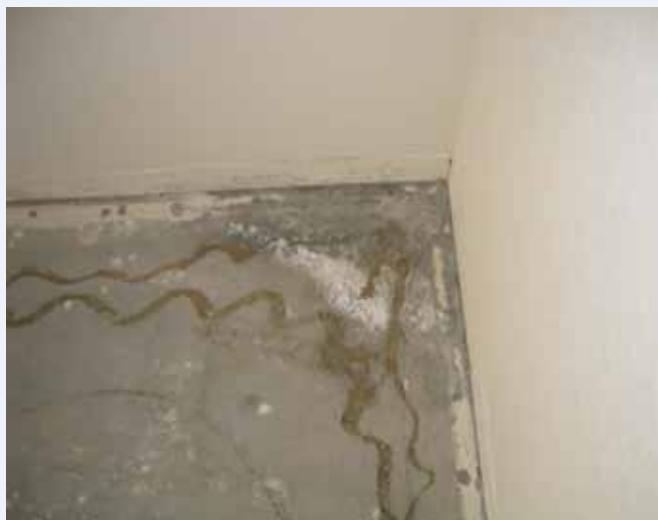
With two months to do the job, the builder's representative was in no hurry to get the remediation complete—so mold growth hurried along without notice.

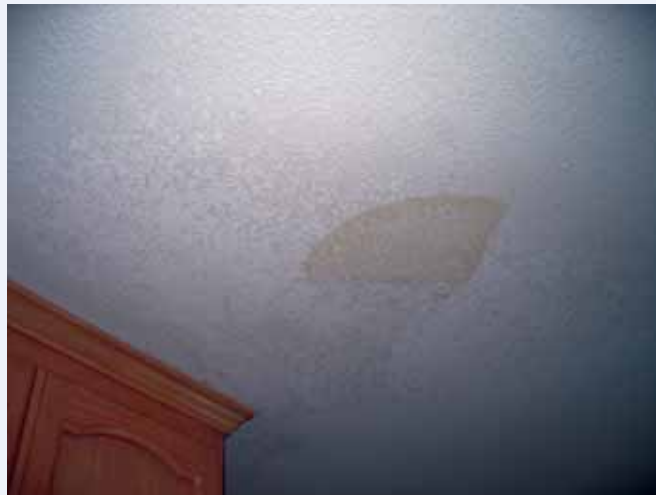
Containments were erected and the inspection of the opened areas revealed mold growth in the ceiling cavities under the decks. The conclusion was that the decks were leaking around the drains and additional remediation would be necessary. The decks overhang the kitchen and downstairs bedrooms. All parties involved were under tremendous pressure by this point. What would the homeowners do when they found their dream home littered with containments and opened ceilings? Yet no one could reach them to find out.

Not surprising from its location below a water-dripping deck, this ceiling measured wet at the first inspection; more surprising, it was not immediately remediated.

Evaluation of the drainage system of the decks revealed that the drain connections had developed gaps and were clogged with leaves and debris. The drainage system for the retaining wall needed to be upgraded to handle the wet winters.
