Working From the Outside In

High Rise Residents Look Out on Mold Remediation

By Peter Sierck, an industrial hygienist and the director of Environmental Testing & Technology Inc. He participated in the development of the IICRC standards S500 for professional water restoration and the S520 for professional mold remediation. Peter can be reached by e-mail at PSierck@IAQsurveys.com.

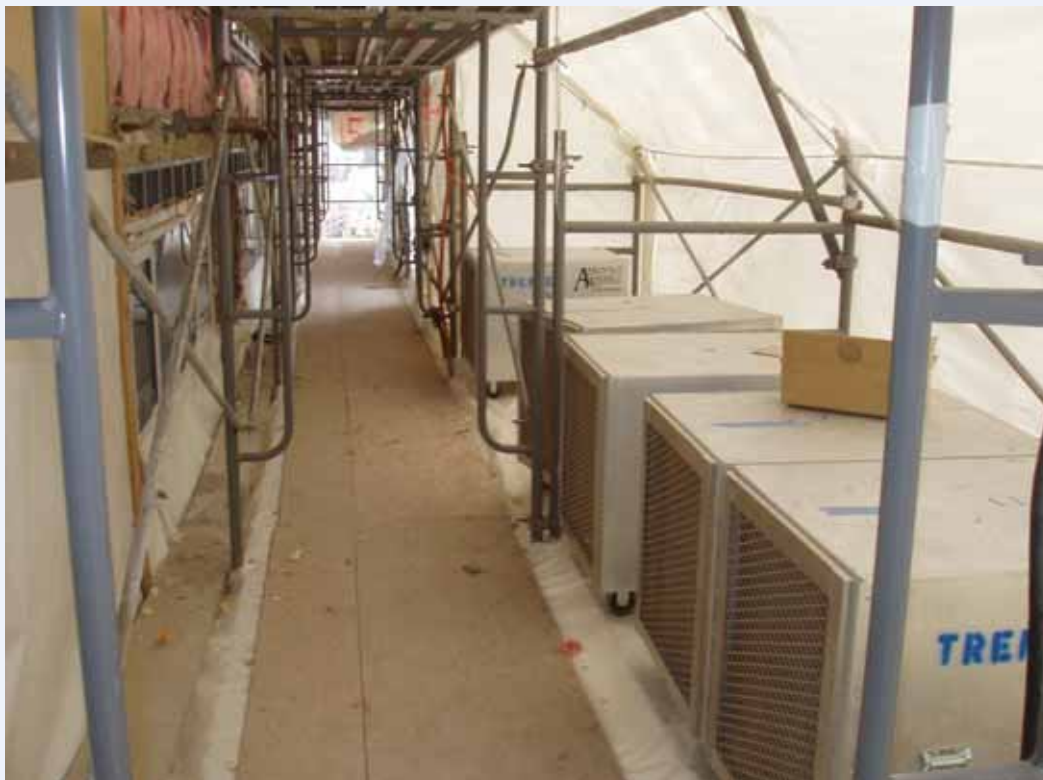
To save the cost of relocating residents, the remediation crew created a negative-pressurized containment around the exterior of this condo.

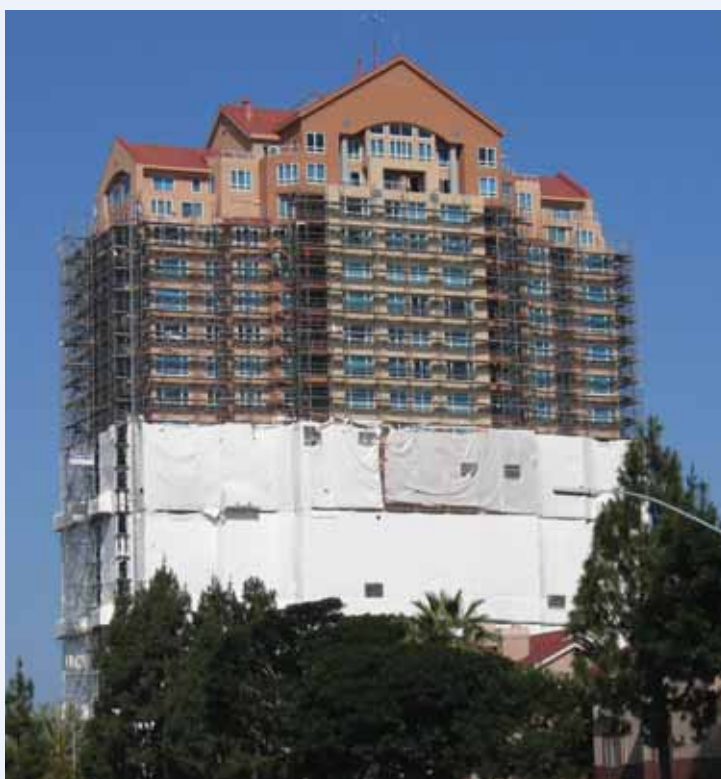
The remediation of this condo offered several challenges, including construction of an exterior containment system upon 21 story scaffolding.
