# Trouble in Paradise

## When Water Damage Creeps into Unoccupied Timeshares

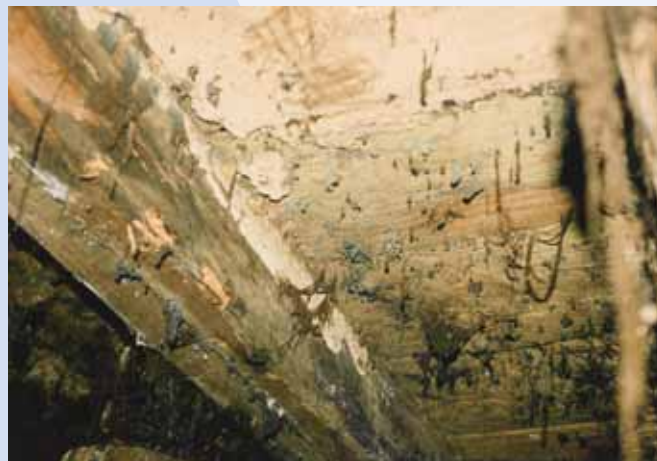
A small amount of mold visible to building occupants can very likely be the sign of bigger problems.

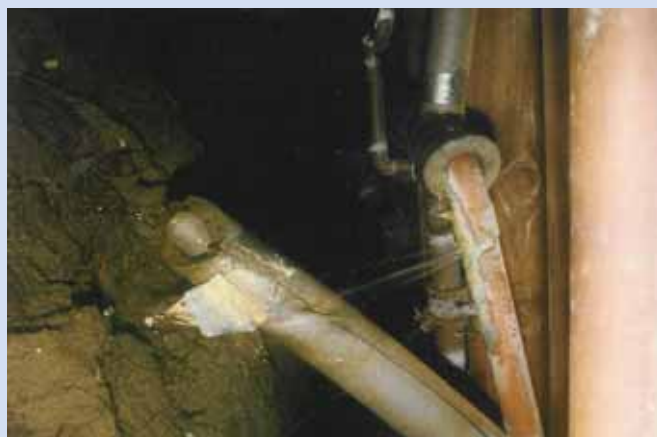
Buildings that aren't occupied regularly may have small problems such as slowly leaking pipes that go undetected for years.

How could such a moisture problem stay undetected for an extended period of time creating such extensive damage? Due to frequent changes in occupancy, odors and other damage may go undetected. So what can a building owner or manager do to prevent this dilemma? The implementation of regular crawl space inspections is not the answer. A better solution is to be aware that all buildings that are not occupied continuously are especially vulnerable to slowly progressing problems that will create great damage in the long run. A higher level of maintenance with regular inspections of all areas in the building, and the immediate response to suspected problems could prevent a big headache in paradise. m
